# Comal County Fairgrounds & Multi-Purpose Facilities

## Master Plan 2023

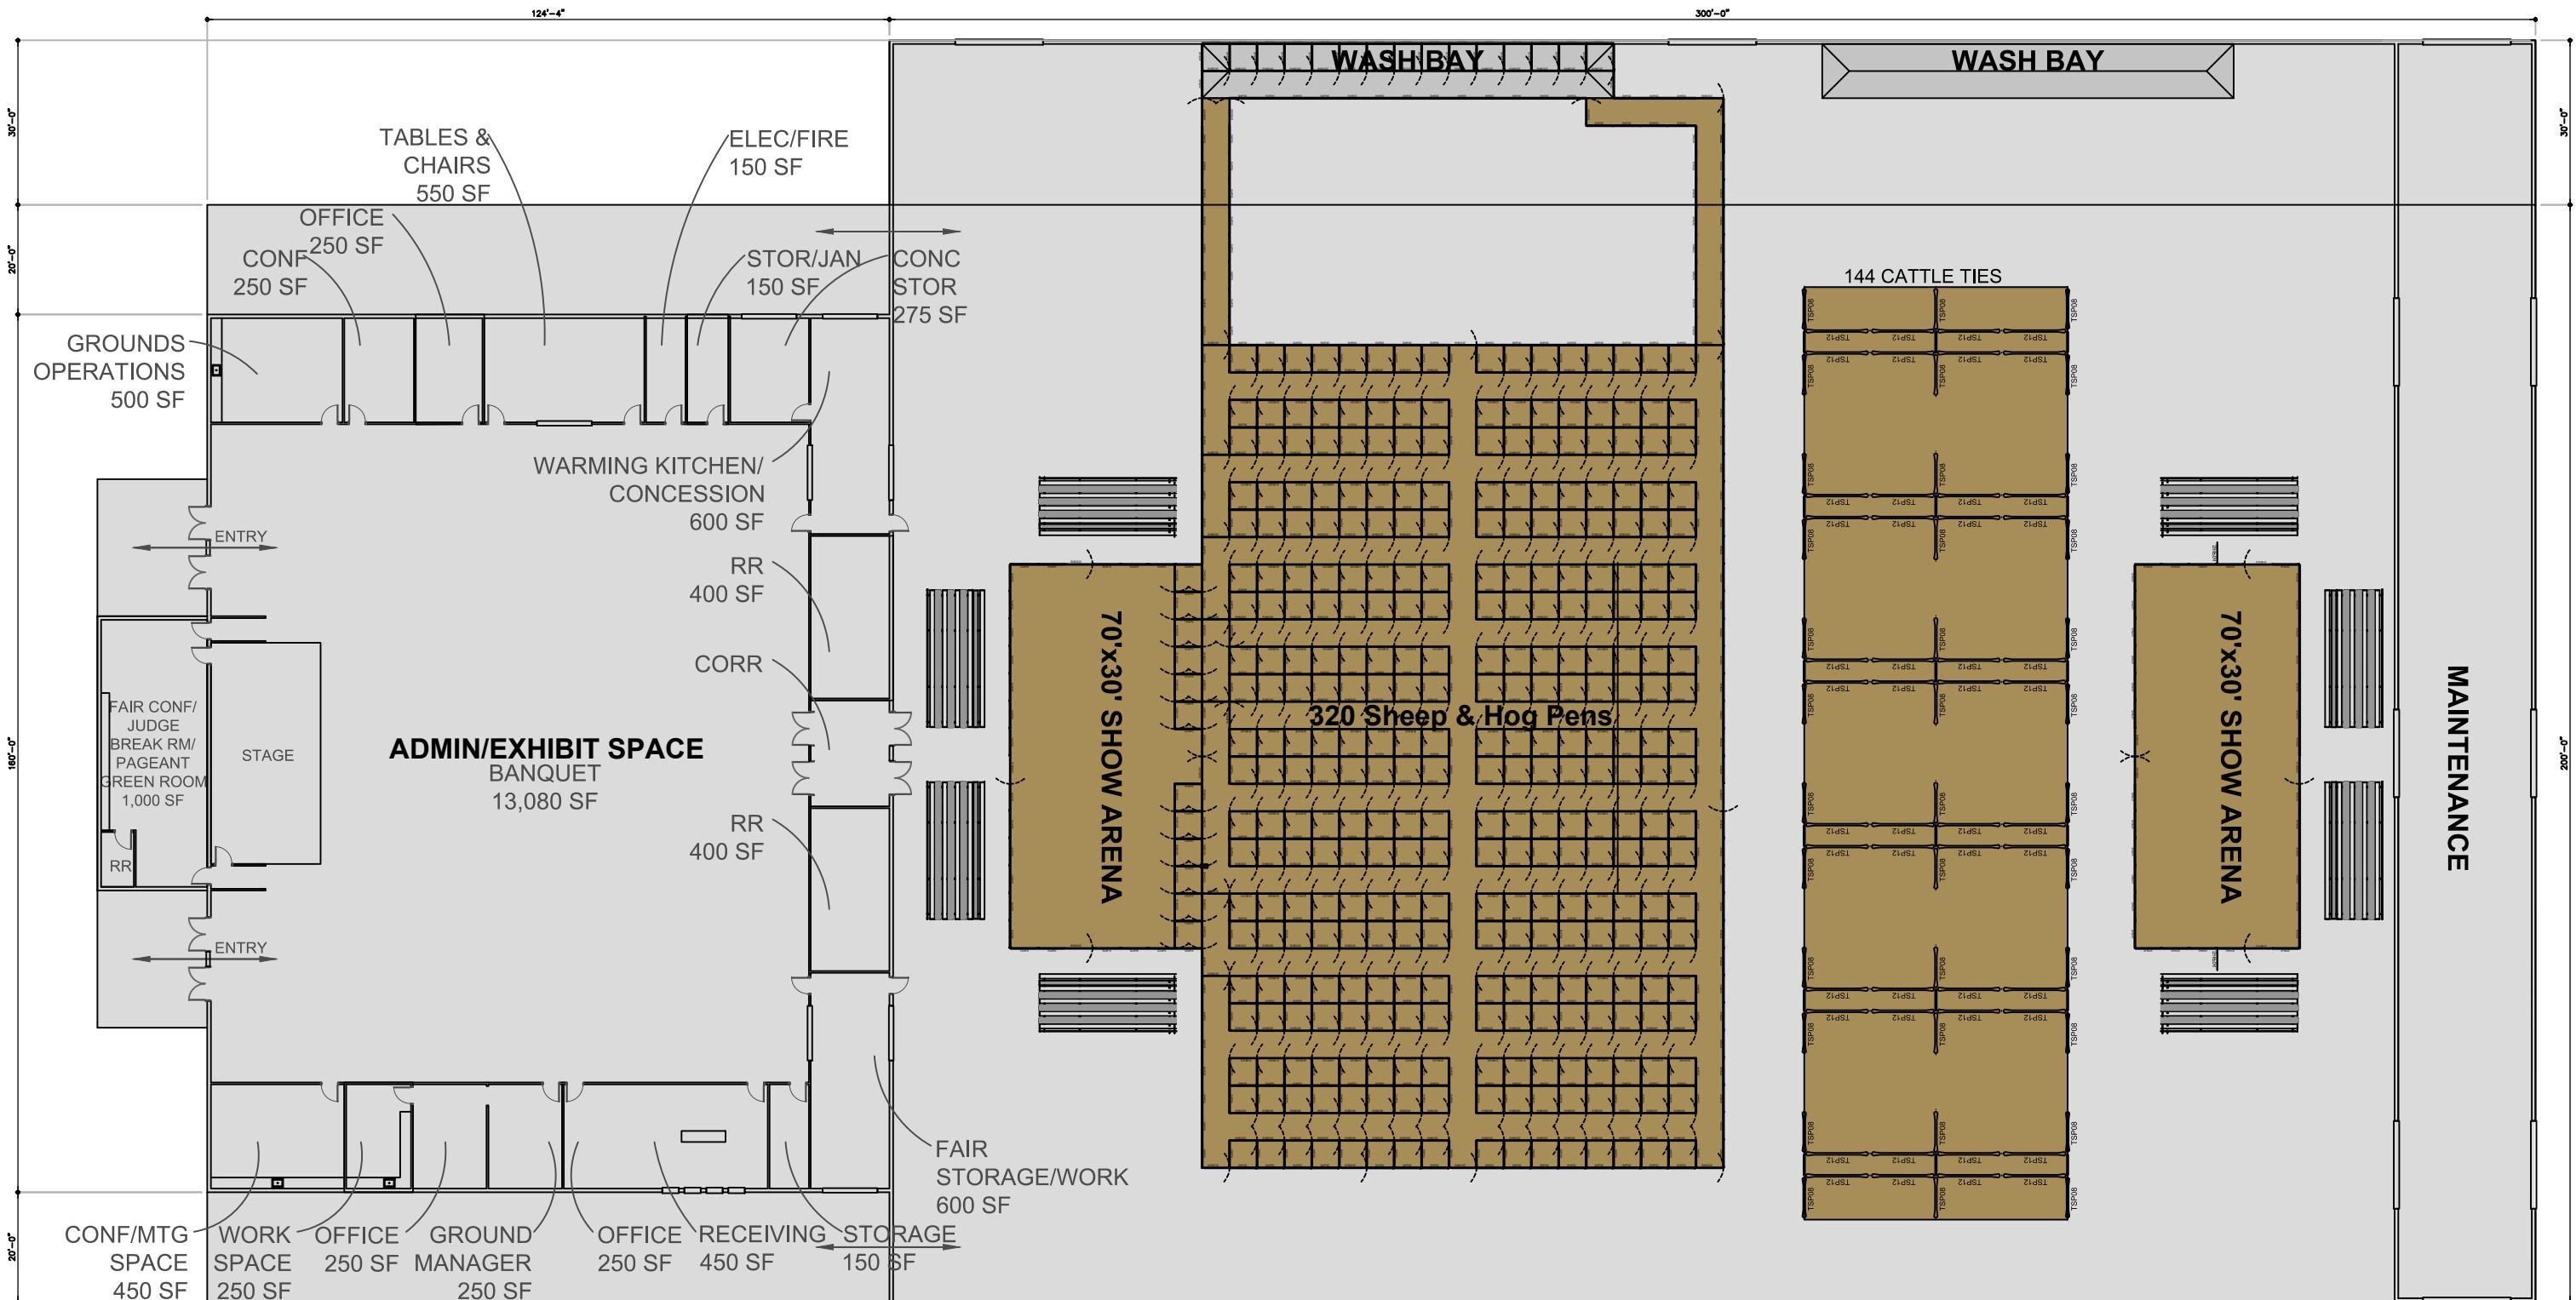
Figure 4: Administration/Multiuse Exhibition Hall

Note: Floor plan shown as example only. Not for construction.

- Ground supported air handlers will condition the Exhibition Building.
- The exterior walls of the pre-engineered metal building are planned to receive economical and durable metal panels with appointments of stone. The building will be covered by a standing seam metal roof.

- Energy code-compliant insulation will form the exposed ceiling. This will provide a bright atmosphere and will improve the acoustics of the space.
- The flooring will be stained concrete, tile, and carpet tile interspersed throughout the exhibition building with a light broom finish in the livestock building. A metal liner panel may be considered as the ceiling of the facility. Ceilings in the exhibitions space will be a combination of suspended acoustical tile and exposed structure.

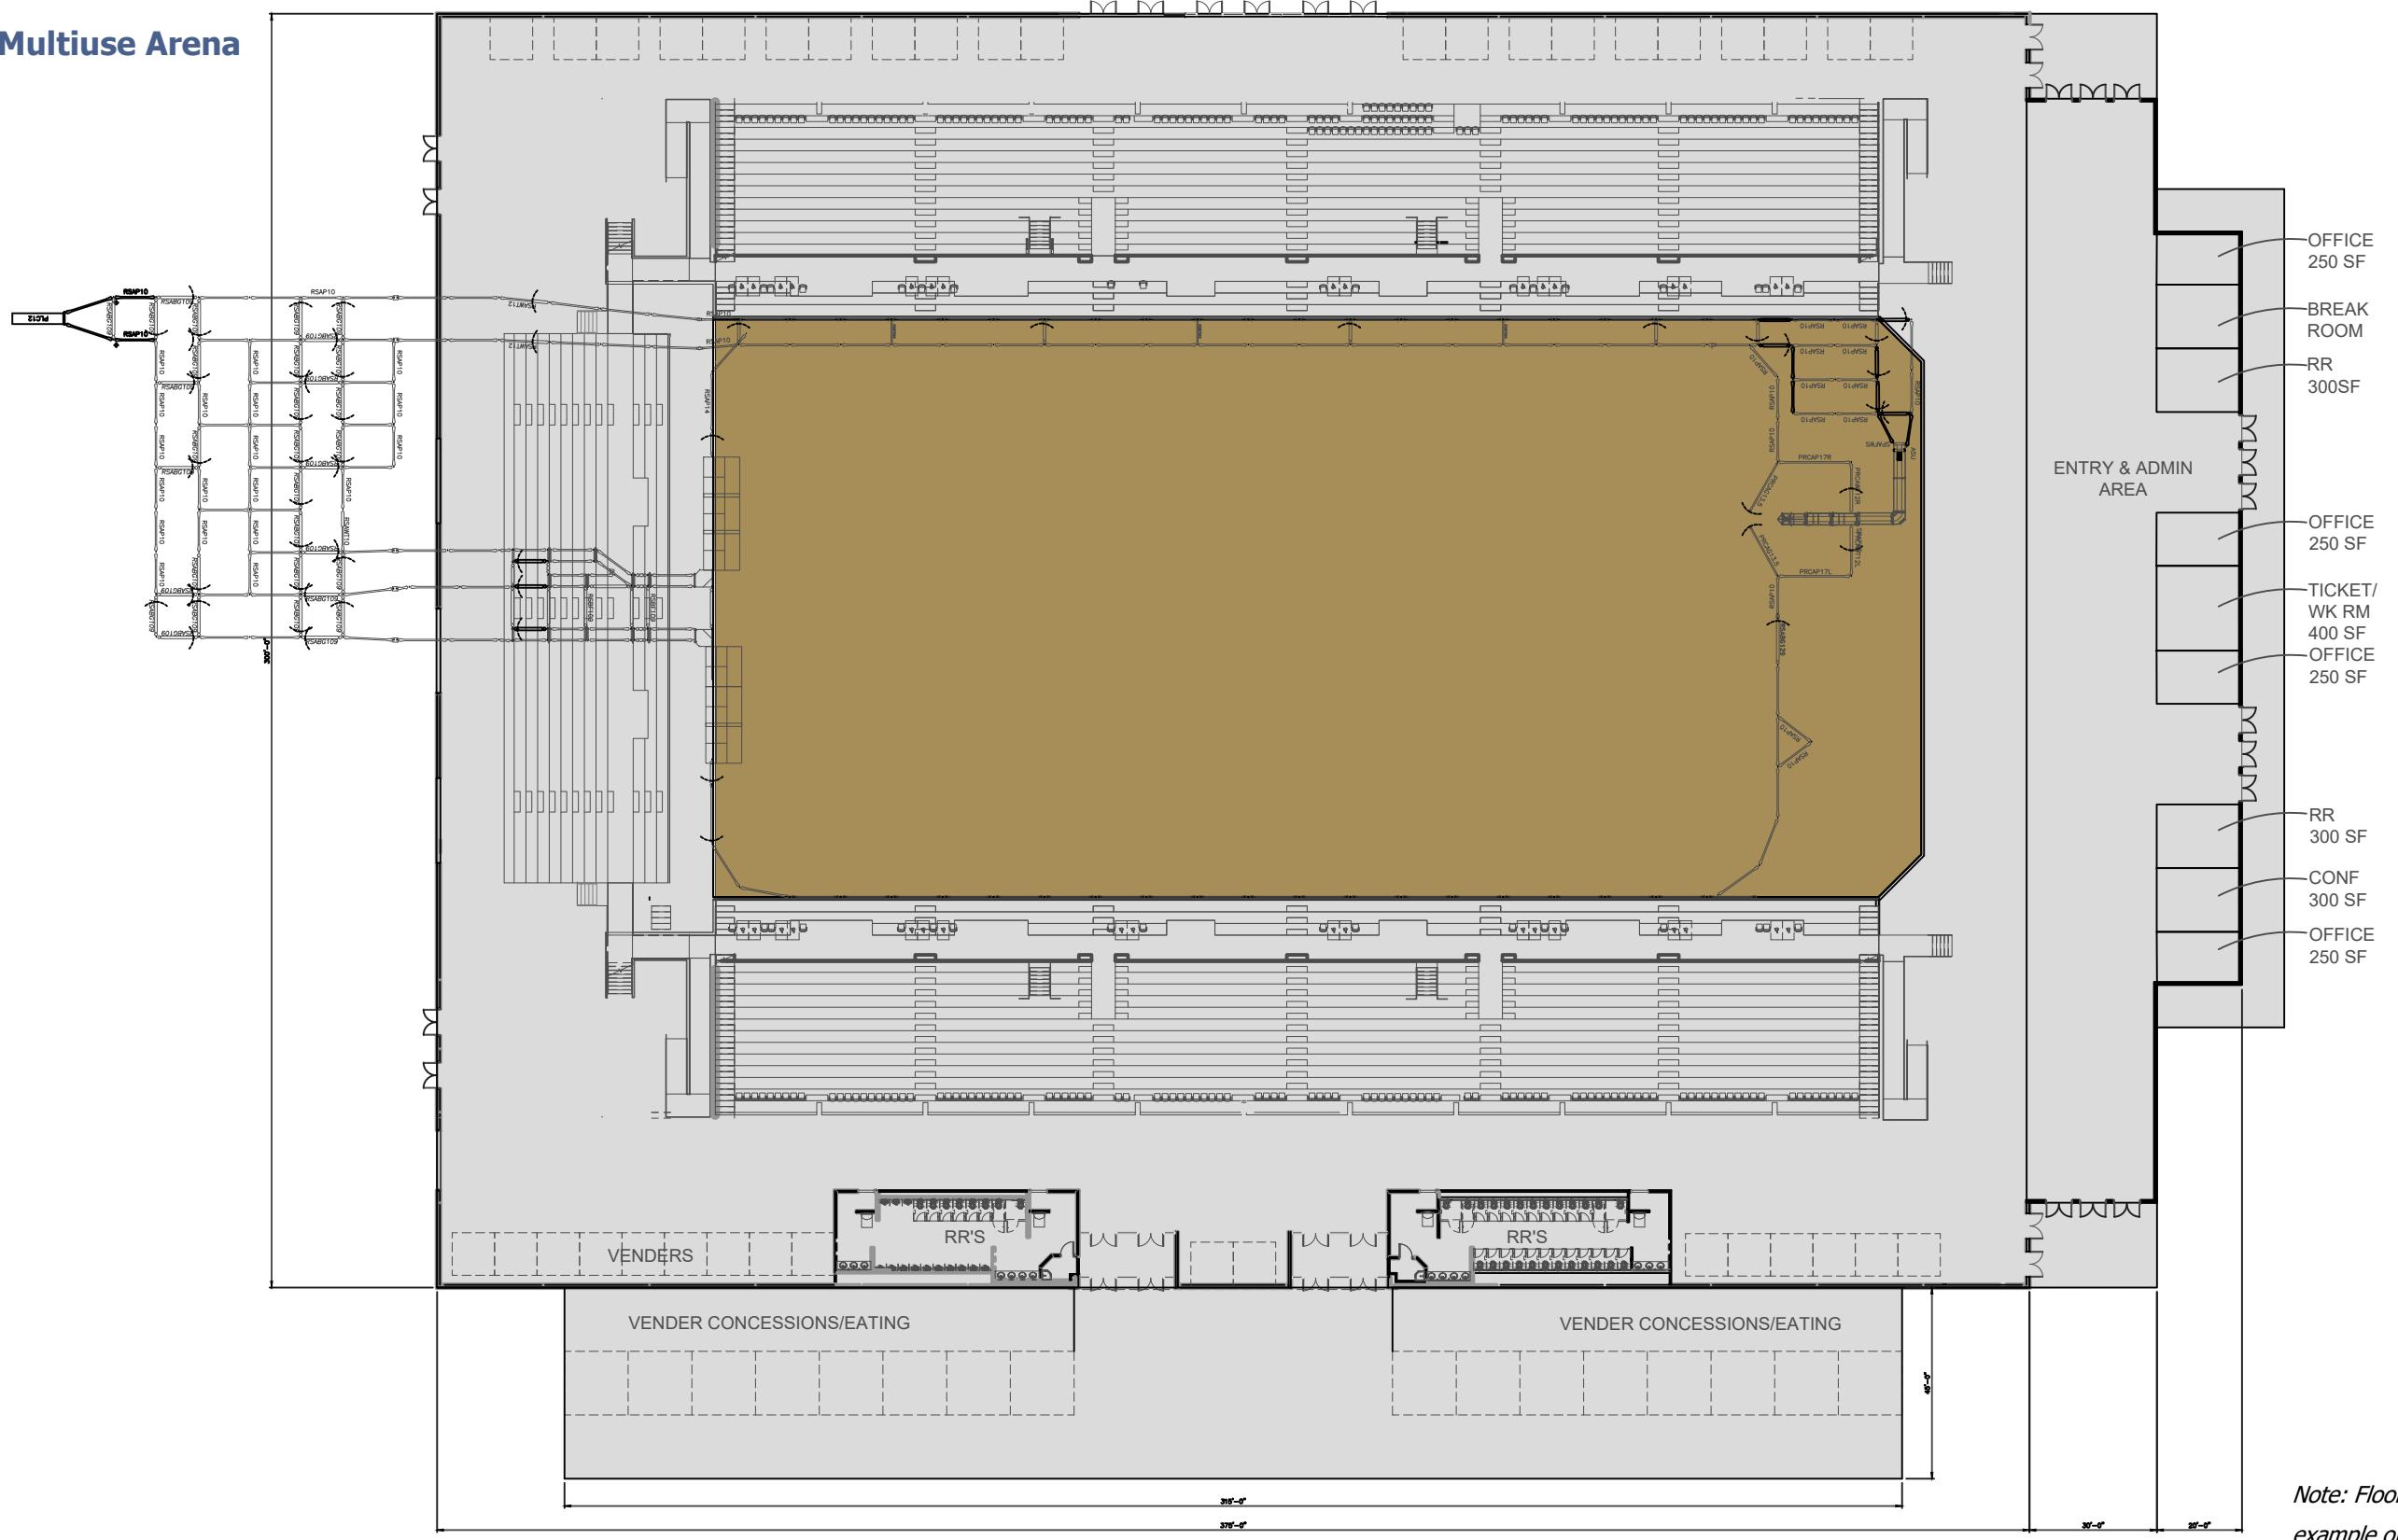
**Figure 5: Multiuse Arena**

*Note: Floor plan shown as example only. Not for construction.*

- The Arena will be enclosed with large fans to supplement the air conditioning system.
- Restrooms will be sized to meet the standard for a building occupancy of 5,000 people (2,500 men and 2,500 women). The restrooms will be of masonry construction to allow for maximum durability and sanitation.

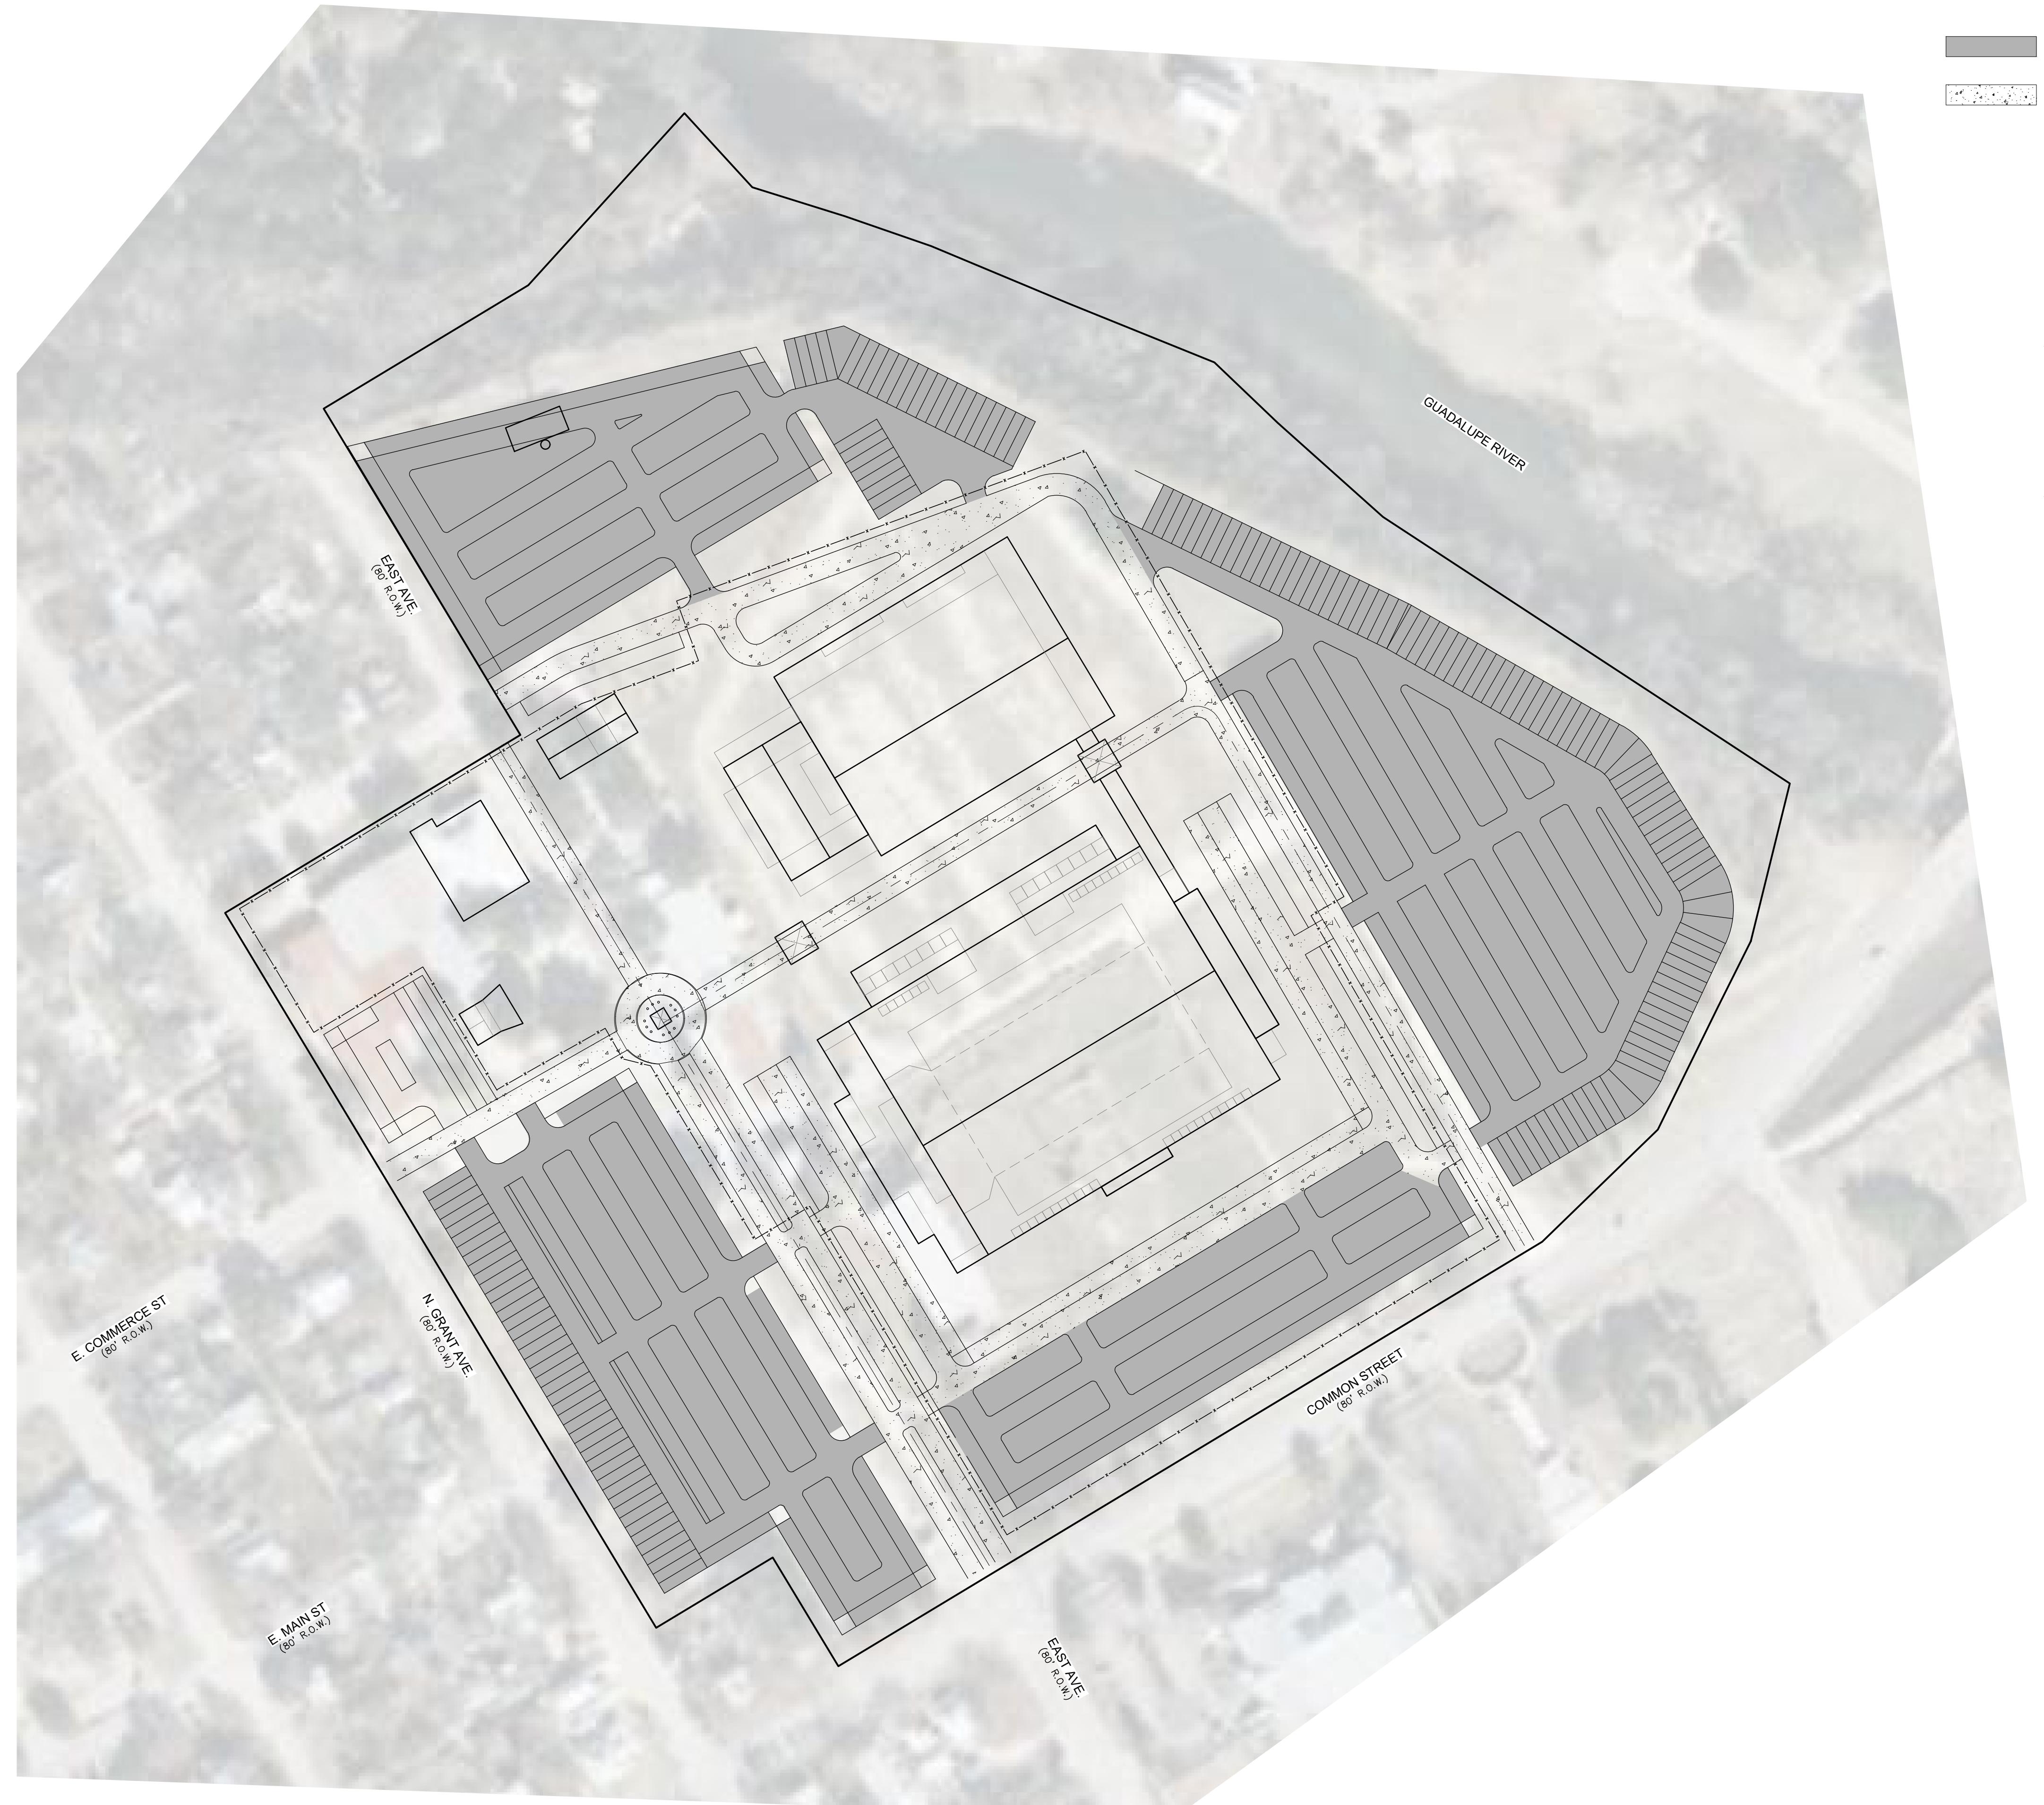
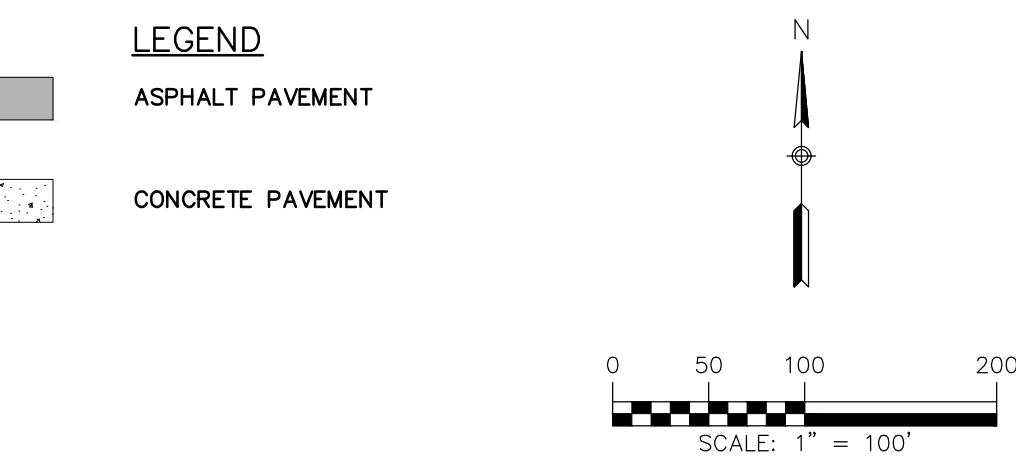
## Exhibit B: Parking

**NOTE:**  
THESE PAVEMENT SECTIONS ARE ASSUMED BASED ON EXPERIENCE AND WERE DONE WITHOUT THE BENEFITS OF A GEOTECHNICAL STUDY/REPORT.

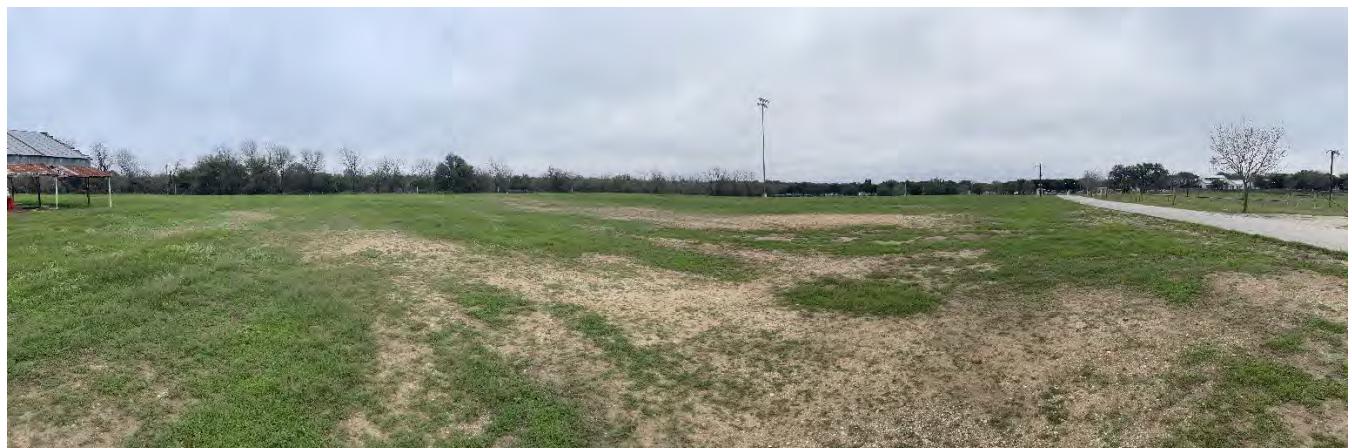
**Field East of Historic Racetrack and Location of Historic Closed Landfill (REC, VEC)**

- The historic landfill represents a Recognized Environmental Condition (REC) to the Site, as the contents of the landfill and any potential impacts to the environment are unknown. In order to determine the presence of any environmental contamination in soil or groundwater, a Phase II Environmental Site Assessment would be required.

- The historic closed landfill on the Site represents a Vapor Encroachment Condition (VEC) to the Site. Although the closed landfill was utilized for domestic municipal solid waste, and no known industrial or hazardous waste was placed in the landfill, it is uncertain if any significant volumes of hazardous substances or petroleum products were placed in the historic closed landfill, which could cause vapor migration of hazardous gases. Therefore, the closed landfill represents a VEC to the Site. A Phase II Environmental Site Assessment would be required to determine if any hazardous gases are migrating from the closed landfill.

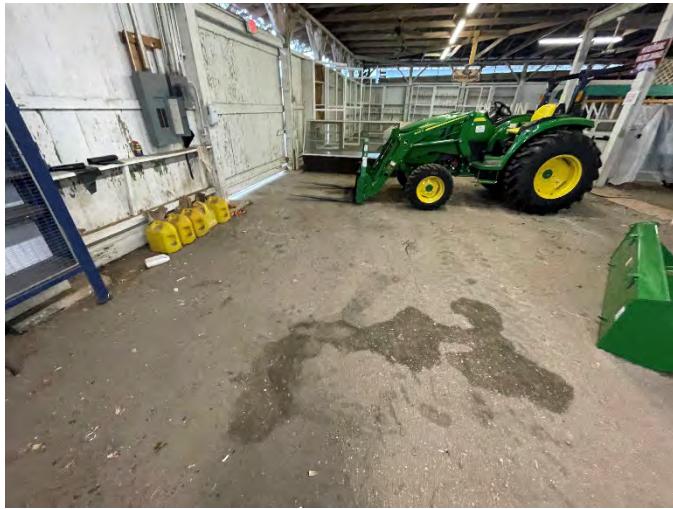
**Example of *De Minimis* Floor Staining in Arts and Crafts Building, and Fuel Can Storage**

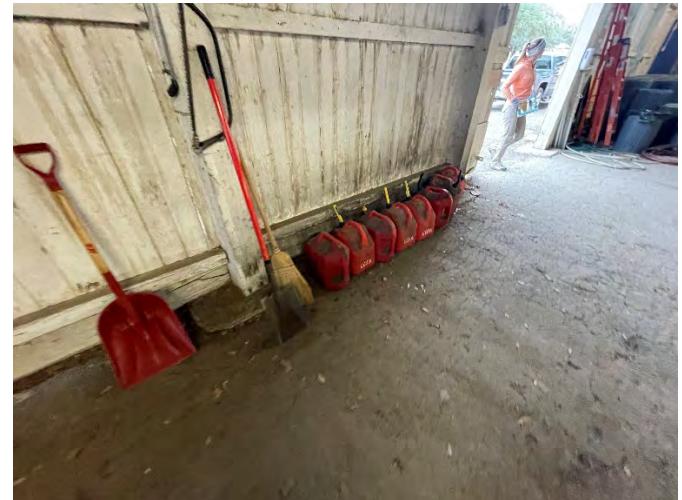
**Fuel Can Storage in Arts and Crafts Building**

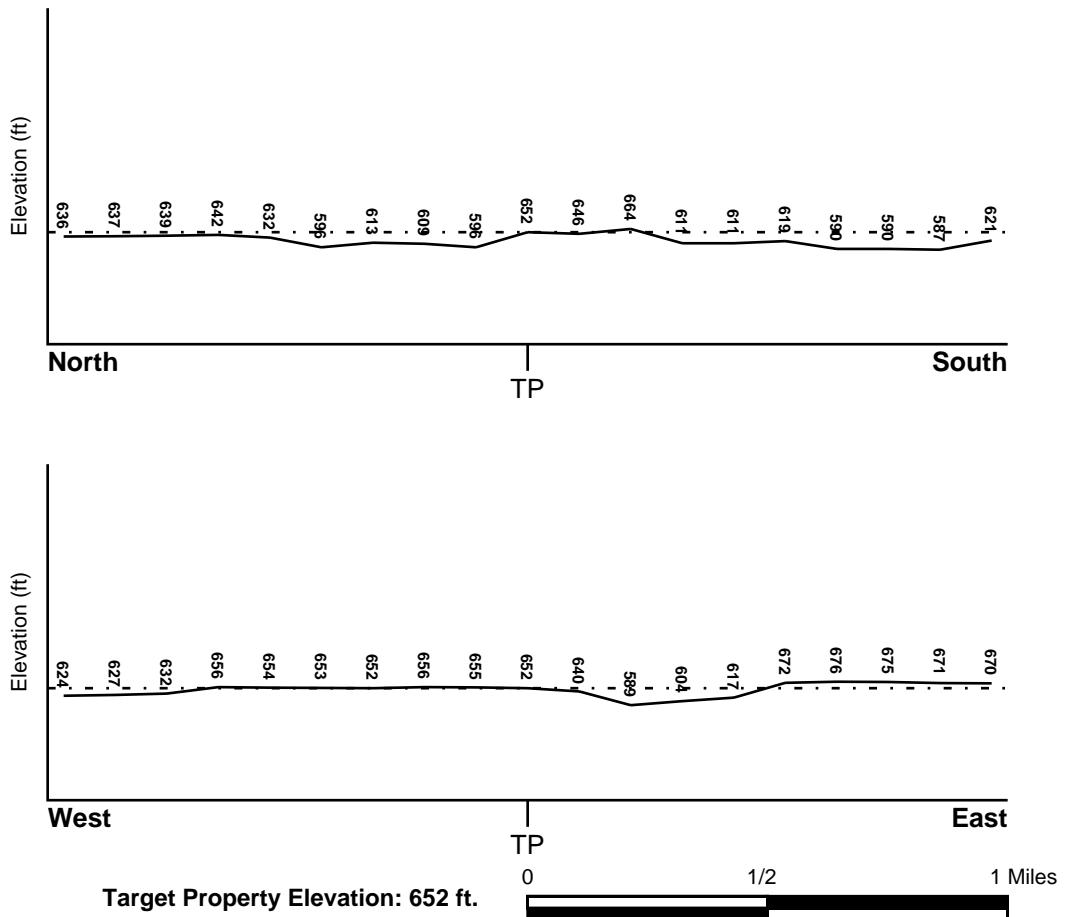
#### **SURROUNDING TOPOGRAPHY: ELEVATION PROFILES**

General Topographic Gradient: General NE

Source: Topography has been determined from the USGS 7.5' Digital Elevation Model and should be evaluated on a relative (not an absolute) basis. Relative elevation information between sites of close proximity should be field verified.
