East Alligator Creek Trail Alignment

East Alligator Creek Existing Conditions

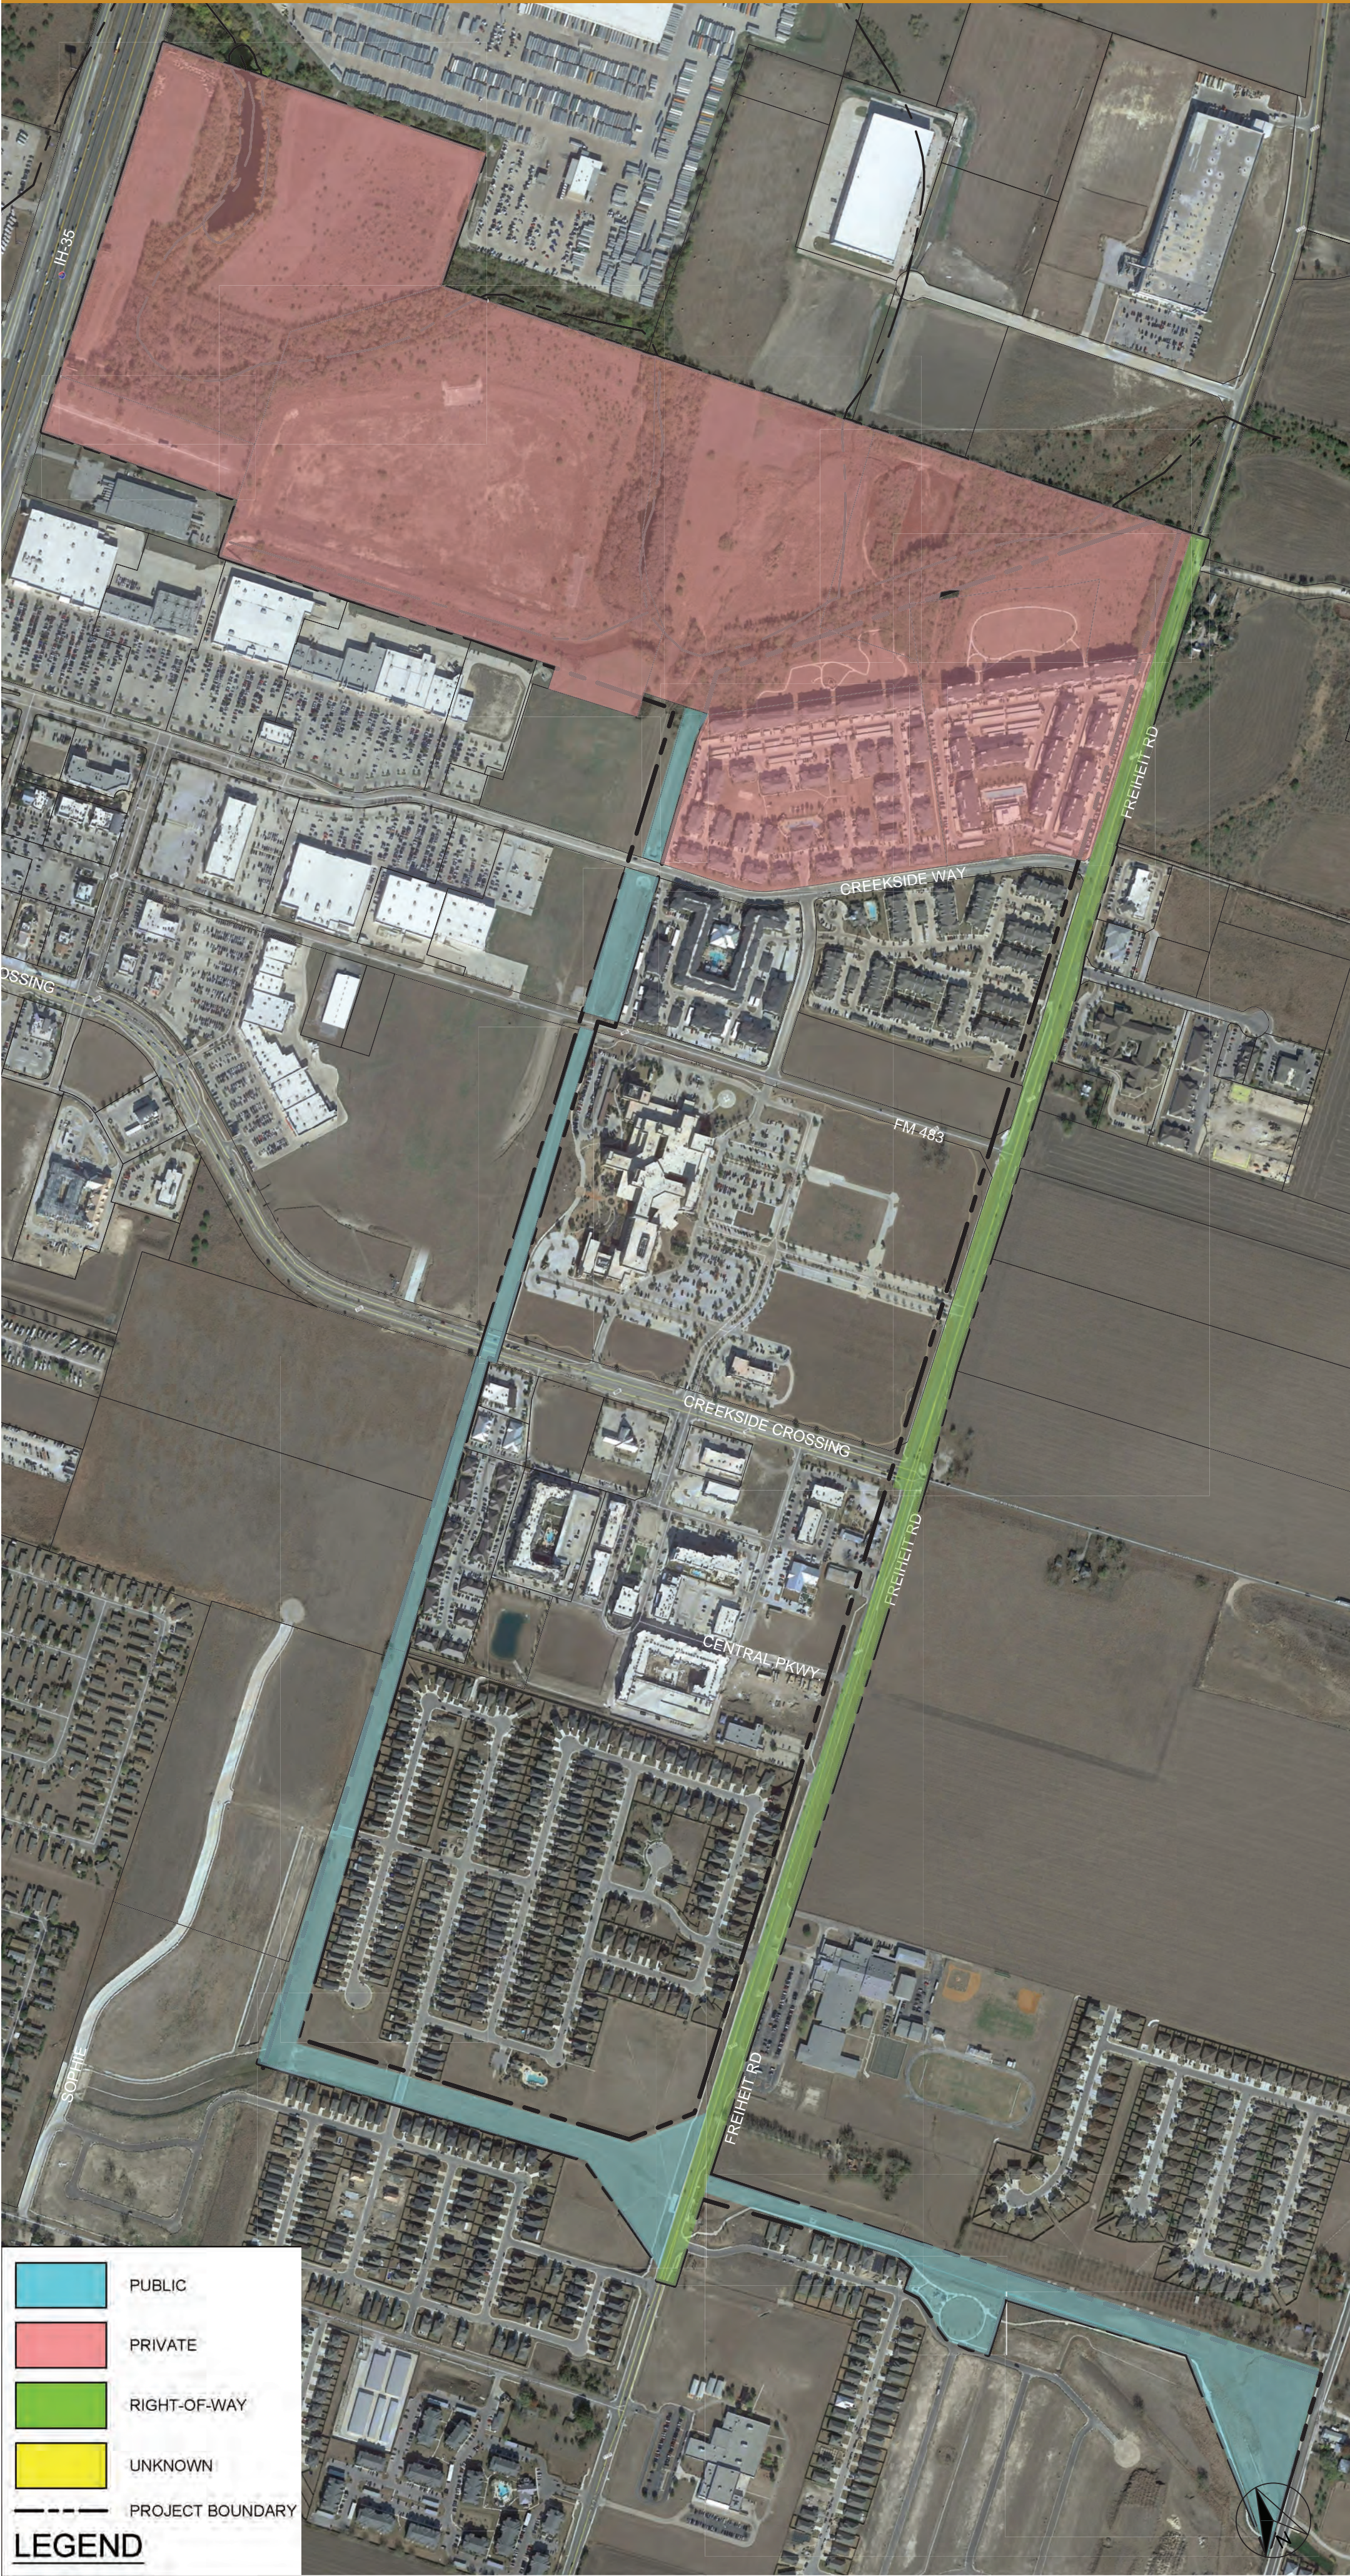
PROPERTY OWNERSHIP

The site analysis consisted of four major factors: property ownership, floodplain areas, existing tree cover, and slopes. The property ownership map indicates public and privately-owned land in the proposed trail area. The floodplain map shows the differing flood risk associated with the proposed trail areas.

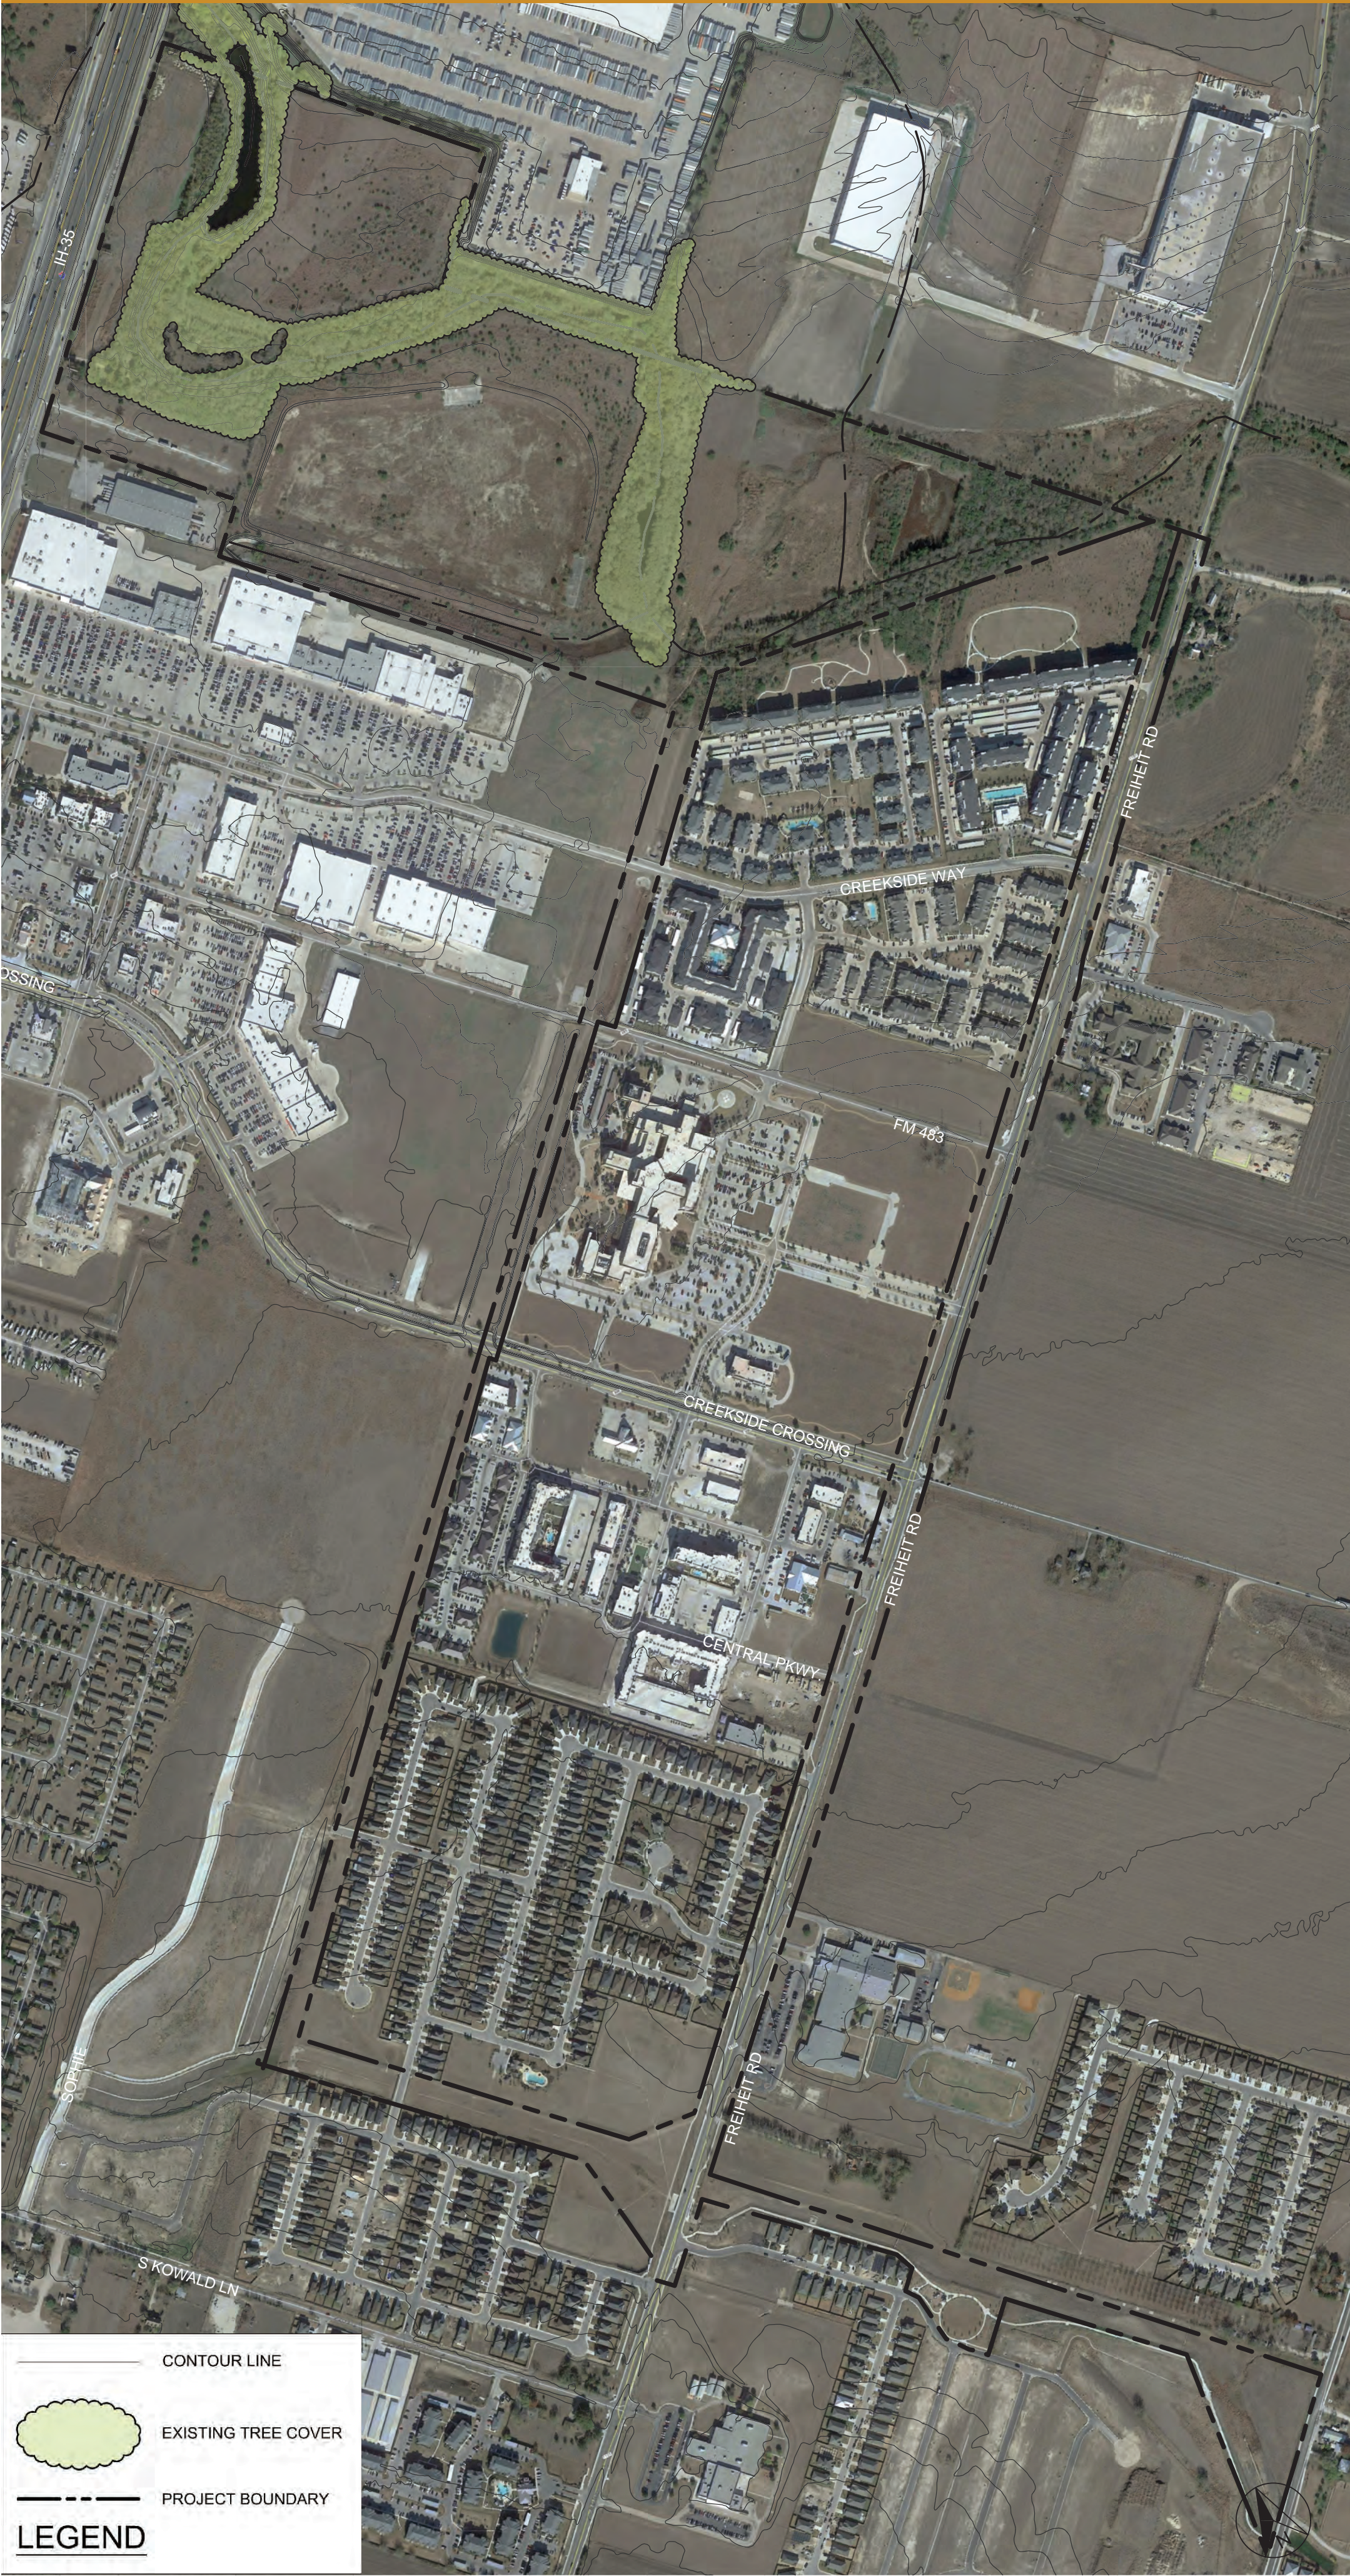
TREE COVER

The tree cover map indicates areas that have existing tree cover. These areas are beneficial for locating portions of the trail, though there is considerable less tree cover for the East Alligator Creek area. The slope map shows the varying degree of slope severity throught the proposed trail area. Existing slopes play an important factor in trail location, both for construction and for ease of access and use for trail users.
